FC Cincinnati Stadium

Review of Akustiks April 9th Report  
for Music Hall

Draft 1 | April 30, 2019

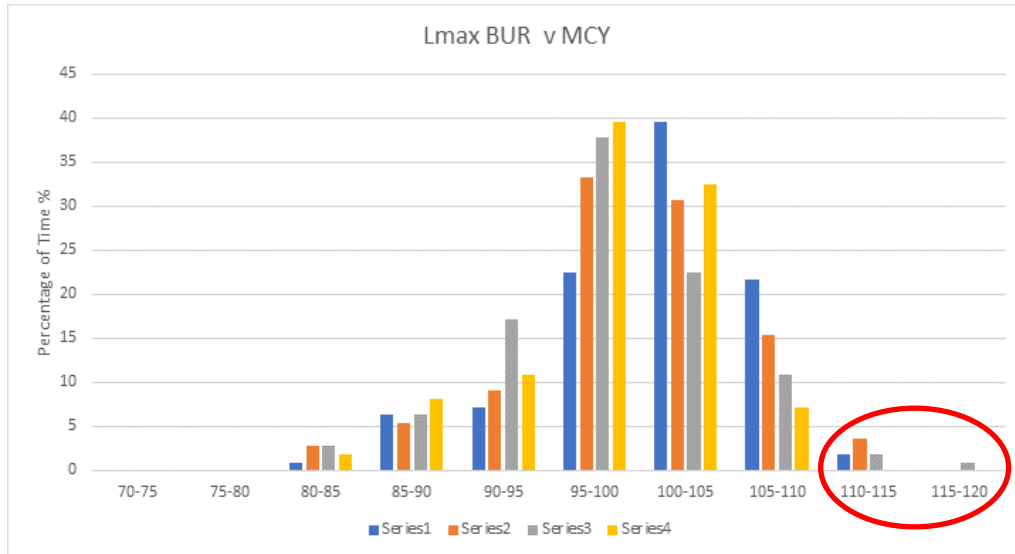
Fig 1a: Categorization of maximum sound levels during 1-minute sound measurements at Burnley v Manchester City 1-0, 14 March 2015

Stadium: *Turf Moor*; seat capacity 22,546

- In three Premier League matches which Arup analyzed, we continuously took one-minute measurements throughout the game. In all three instances, we found that instantaneous peak sound levels exceeded 110 dBA in the seated areas within only 3 to 4% of our one-minute measurements during each match. See Figures 1a through 1c.

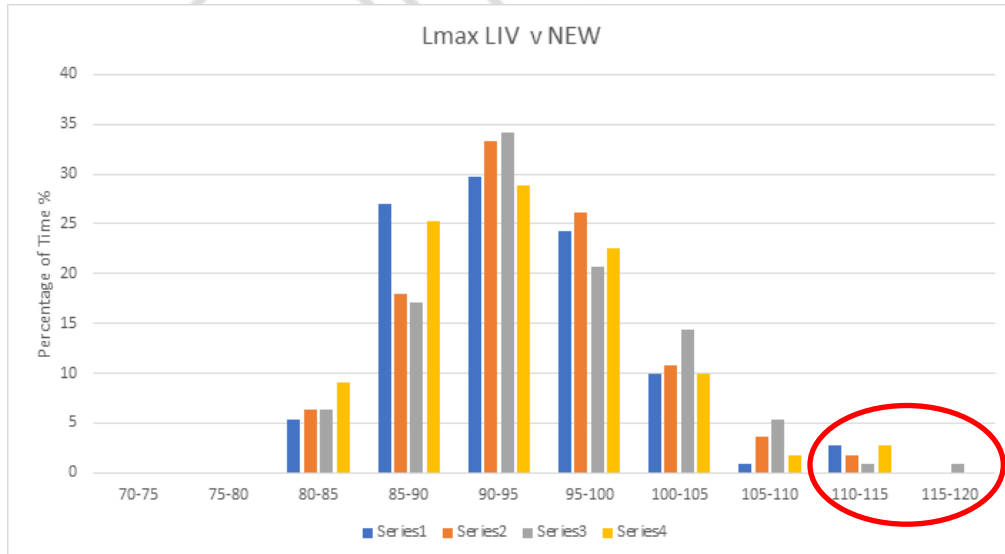
Fig 1b: Categorization of maximum sound levels during 1-minute sound measurements at Liverpool v Newcastle 2-0, 13 April 2015

Stadium: *Anfield*; seat capacity 54,074

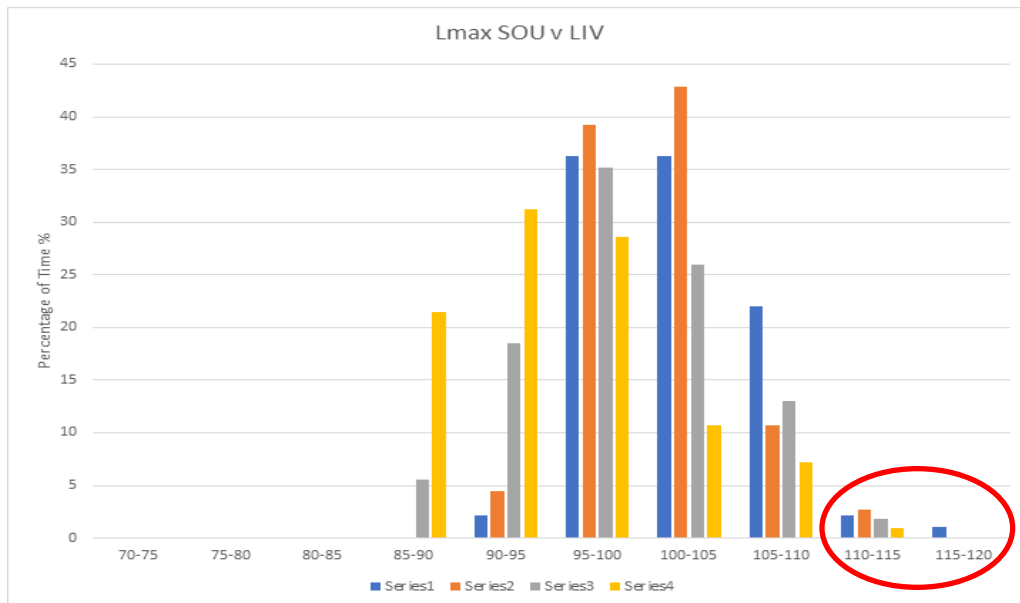
Fig 1c: Categorization of maximum sound levels during 1-minute sound measurements at Southampton v Liverpool 0-2, 22 February 2015

Stadium: St. Mary's; seat capacity 32,505

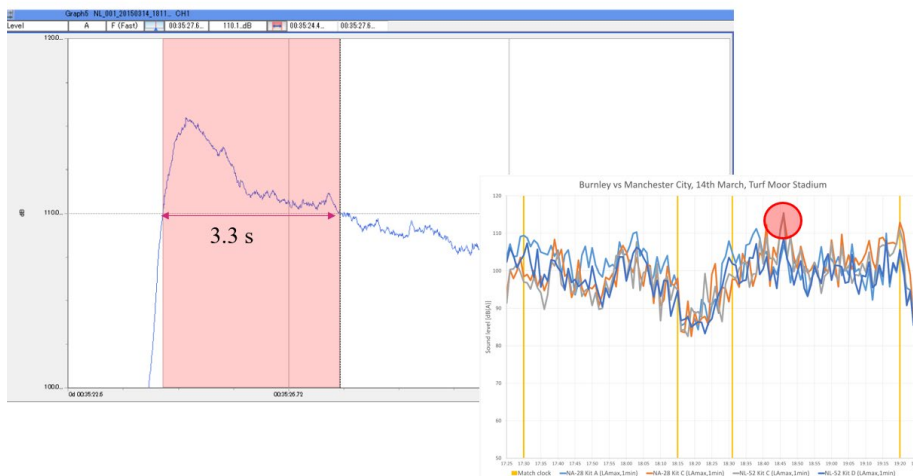
## Burnley vs. Manchester City, 14<sup>th</sup> March, Turf Moore

Jimmy McIlroy Stand – Middle,  $L_{max, 1min}$ : 116 dBA,  $L_{eq, 1min}$ : 103dBA

Fig 2a: Time envelope of sound levels exceeding 110 dBA for selected peak crowd noise moment during the referenced match

- Within each 1-minute long measurement, no single event generated instantaneous peak levels which exceeded 110 dBA for longer than 3.6 seconds. Samples from the highest peaks in each match are shown in figures 2a through 2f.

Figures 2a through 2f in this report demonstrate that peak crowd noise from the Stadium will generally last less than 4 seconds in duration. However, our rooftop measurements at Music Hall found sirens can last longer depending on the number of emergency vehicles. Sample siren durations taken during our survey were found to exceed both 71 dBA and 77 dBA levels for 10 to 38 seconds (see Figure 5). As such, these siren events last significantly longer than the crowd noise peaks described in the Akustiks report.

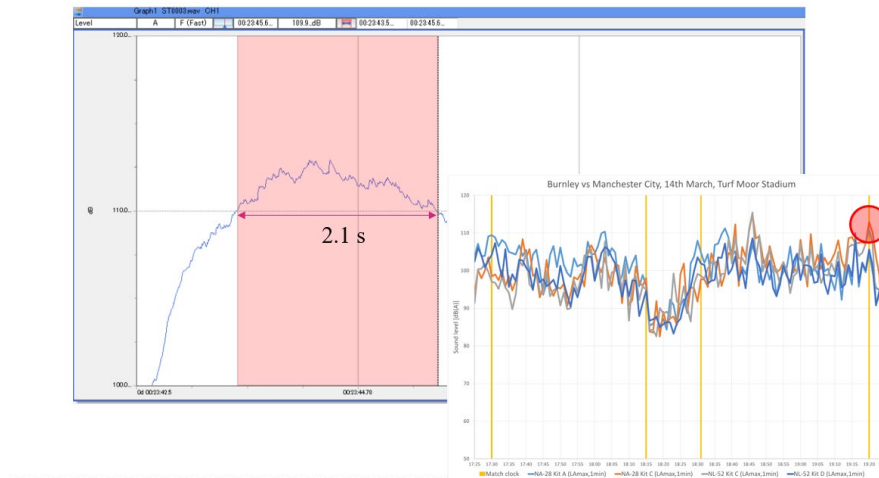
## Burnley vs. Manchester City, 14<sup>th</sup> March, Turf Moor

Jimmy McIlroy Stand – Middle,  $L_{\max, 1\text{min}}$ : 113 dBA,  $L_{\text{eq}, 1\text{min}}$ : 102 dBA

Fig 2b: Time envelope of sound levels exceeding 110 dBA for selected peak crowd noise moment during the referenced match

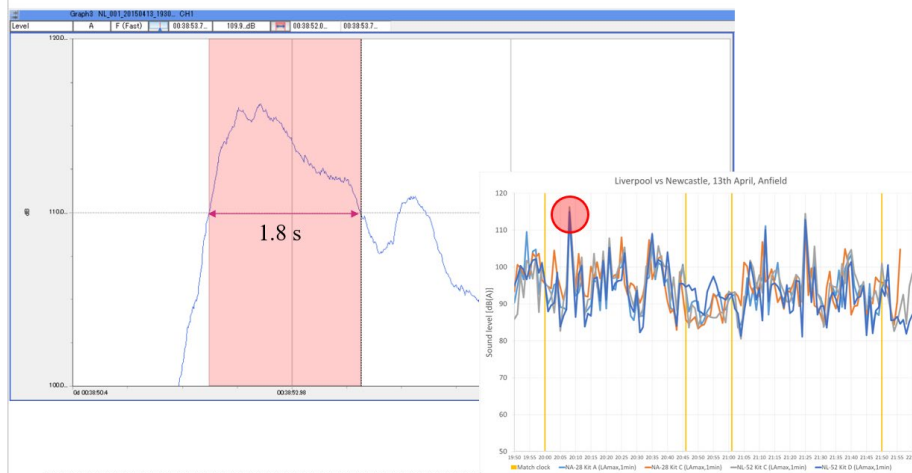
## Liverpool vs. Newcastle, 13<sup>th</sup> April, Anfield

Main Stand,  $L_{\max, 1\text{min}}$ : 116 dBA,  $L_{\text{eq}, 1\text{min}}$ : 101 dBA

Fig 2c: Time envelope of sound levels exceeding 110 dBA for selected peak crowd noise moment during the referenced match

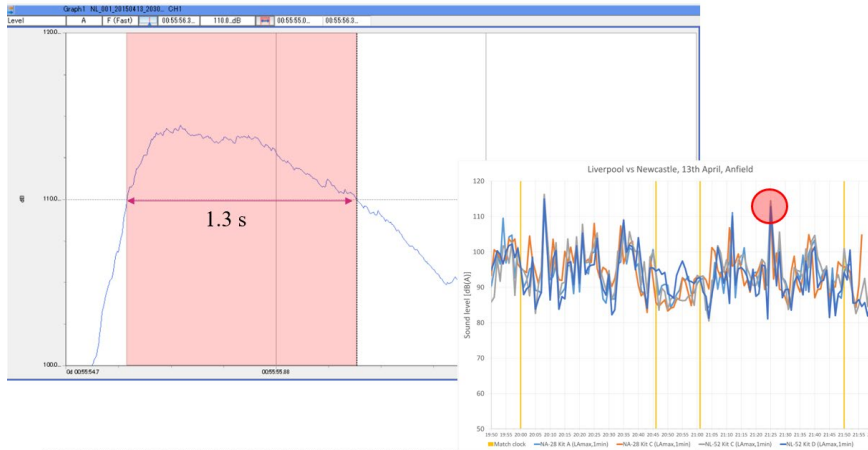
## Liverpool vs. Newcastle, 13<sup>th</sup> April, Anfield

Main Stand,  $L_{\max, 1\min}$ : 115 dBA,  $L_{\text{eq}, 1\min}$ : 98 dBA

Fig 2d: Time envelope of sound levels exceeding 110 dBA for selected peak crowd noise moment during the referenced match

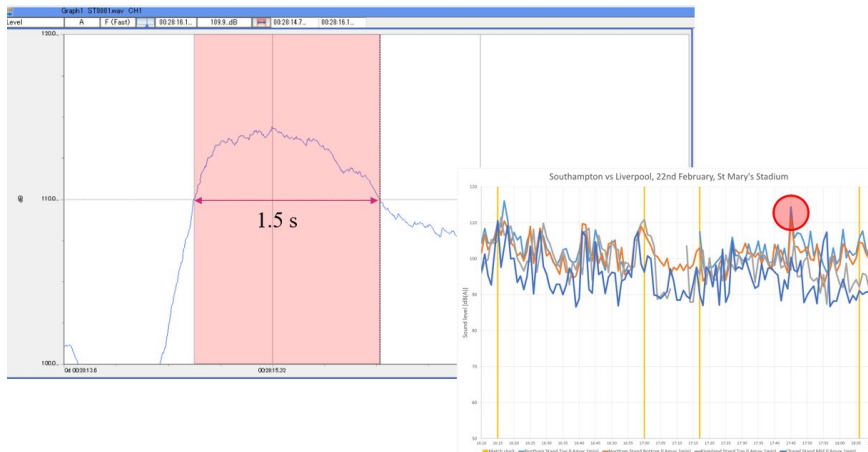
## Southampton vs. Liverpool, 22<sup>nd</sup> February, St Mary's Stadium

North Stand-Top,  $L_{\max, 1\min}$ : 114 dBA,  $L_{\text{eq}, 1\min}$ : 102 dBA

Fig 2e: Time envelope of sound levels exceeding 110 dBA for selected peak crowd noise moment during the referenced match

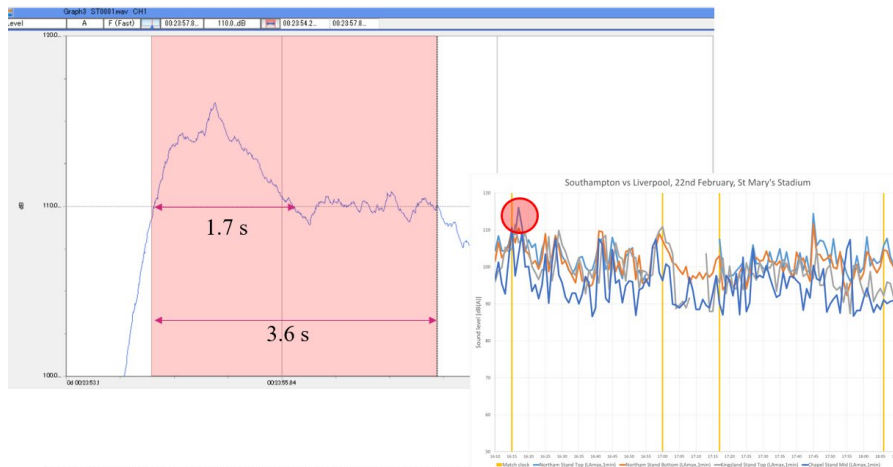
### Southampton vs. Liverpool, 22<sup>nd</sup> February, St Mary's Stadium

Northam Stand-Top,  $L_{\max, 1\min}$ : 116 dBA,  $L_{eq, 1\min}$ : 102 dBA

Fig 2f: Time envelope of sound levels exceeding 110 dBA for selected peak crowd noise moment during the referenced match

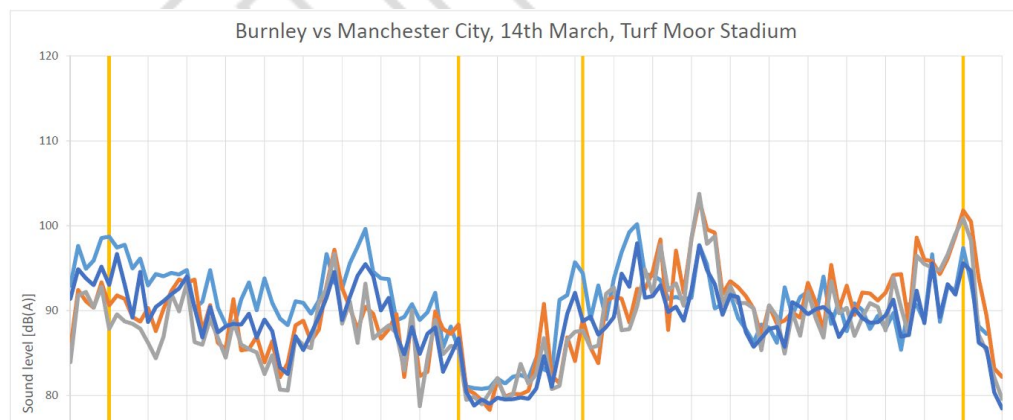
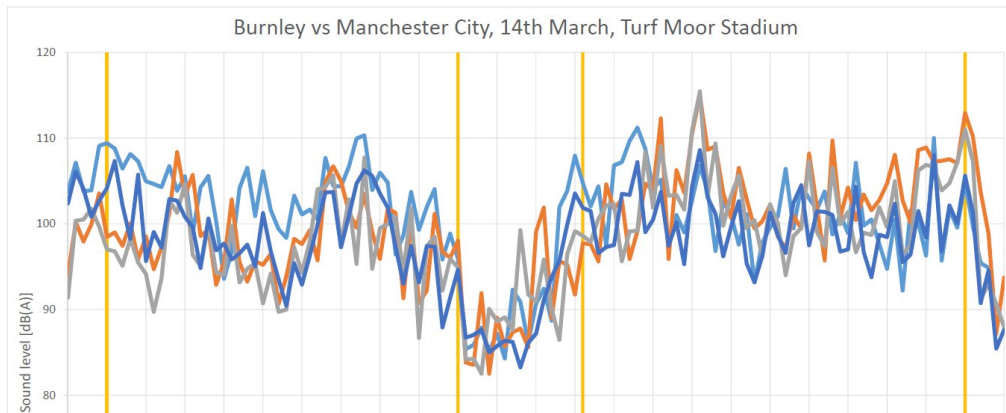
Fig 3a and 3b: Yellow vertical lines indicate match start, halftime and end of match. Graphed data represents measurements in four different locations around the seating bowl. As shown, peak levels (lower graph) are 10 dB or higher above average levels (upper graph).

- After these instantaneous peaks occur, crowd noise trends back to the average sound levels sustained over the course of the match. Equivalent average sound levels ( $L_{eq}$ ) sustained by the crowd during these matches were at least 10 dBA less than peak levels, as seen in Figures 3a and 3b.

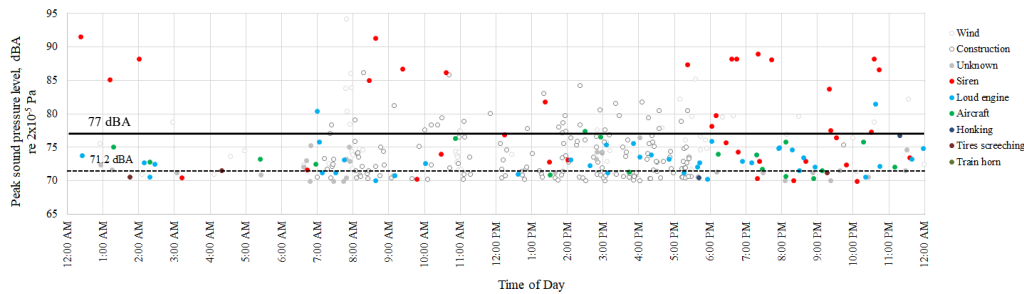
Figure 4 – Aggregate of one week of measurements on Music Hall roof, conducted from April 10 to 17<sup>th</sup>. Solid line represents peak crowd noise predictions from the Akustiks report. Dashed line represents the same with a 6 dB “tonal noise” penalty applied.

From April 10 to April 17, 2019, Arup conducted attended and unattended continuous measurements on the roof of Music Hall (see Appendix). During these seven days, we captured many discrete events from common sources which were as loud or louder than the predicted level of peak crowd noise (77 dBA) from the Stadium.

Of all the outdoor noise sources we measured from the roof of Music Hall, the most significant exceedances were from sirens, some of which were as much as 15 dBA above Akustiks' predictions of the new Stadium peak crowd levels.

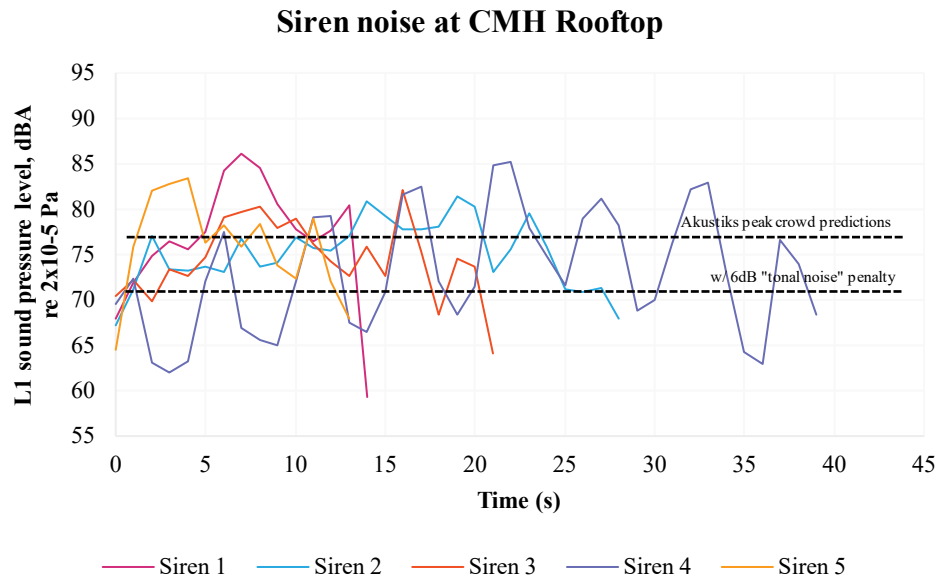
Figure 5 – Sampling of five siren events measured by Arup on Music Hall roof.

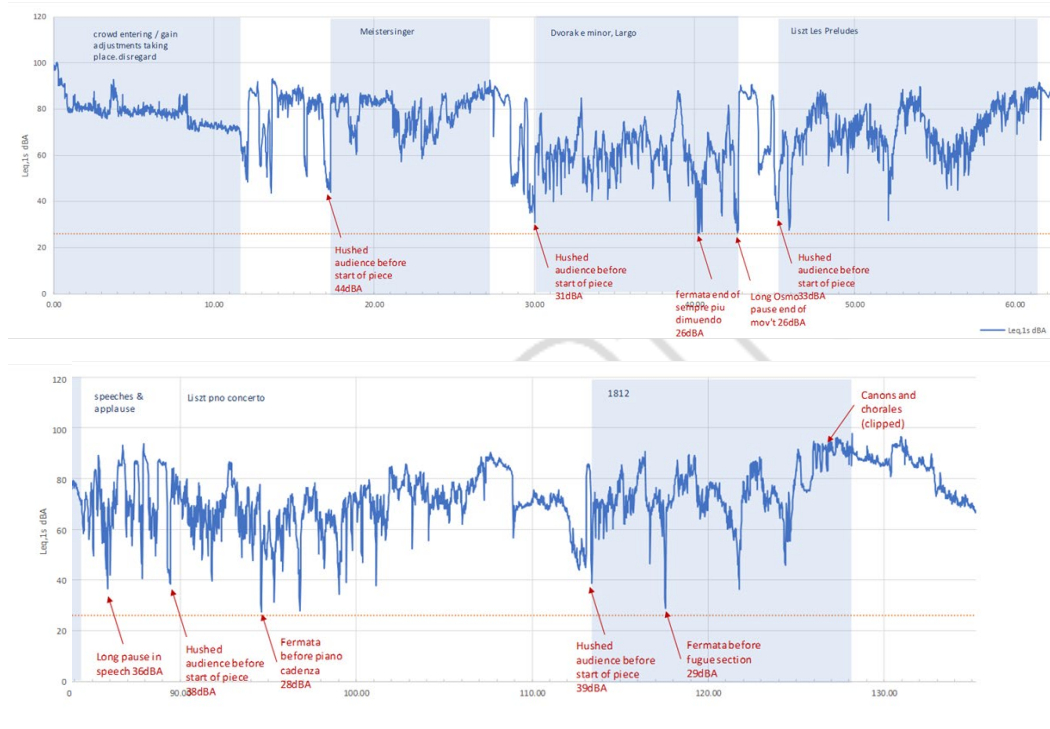
Figure 8 – Sound Levels during Minnesota Orchestra performance at Northrop Auditorium, 2014.

Arup does not have access to any measurements during sample performances at Music Hall. However, we do have recordings and measurements from a 2014 performance of the Minnesota Orchestra taken at Northrop Auditorium, which has an unoccupied background noise level of NC 15.

- Over the entire performance, there were six total moments in the concert where fermata (pauses) occurred and approached within 5 dB of the occupied background noise level.

- Moreover, over the course of the performance, the sound level was more than 5 dB above background sound 99.66% of the time.
- As such, because the total duration of these hushed pauses was only 0.34% of the concert, and because the peak sound levels during a soccer match generally last for less than 4 seconds and occur less than 4 percent of the match, it is very unlikely that peak crowd noise would have an intrusive effect on a Music Hall event.

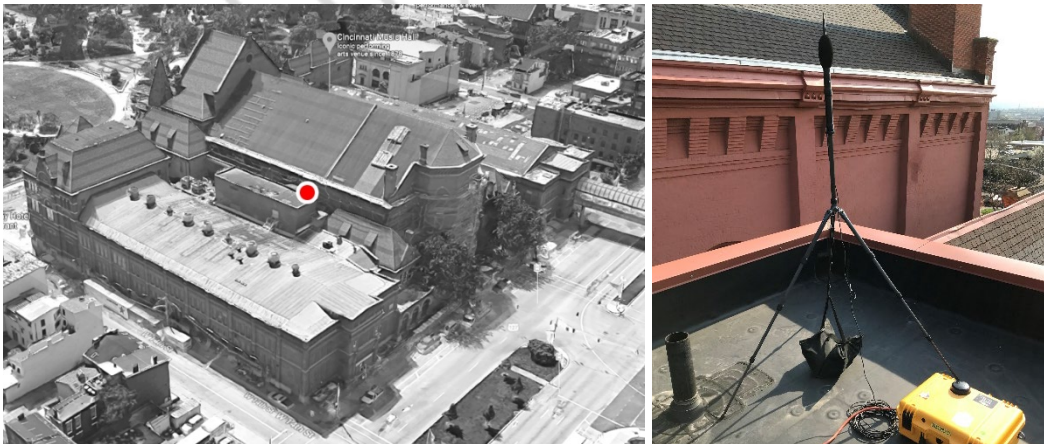
Figure A1 – Rooftop logging kit location

Logging kit 2926303 was set up at the southeast corner of the north mechanical penthouse roof, with the microphone at a height of 5'11" above the penthouse roof surface, shown in Figure A1. This location was the closest accessible position to the pitched roof over Springer Auditorium with line of sight to West Central Parkway and Ezzard Charles Drive, as shown in Figure A2. The line of sight to West Central Parkway from higher the pitched roof would be less obstructed, while the line of sight to Ezzard Charles Drive would be more obstructed.

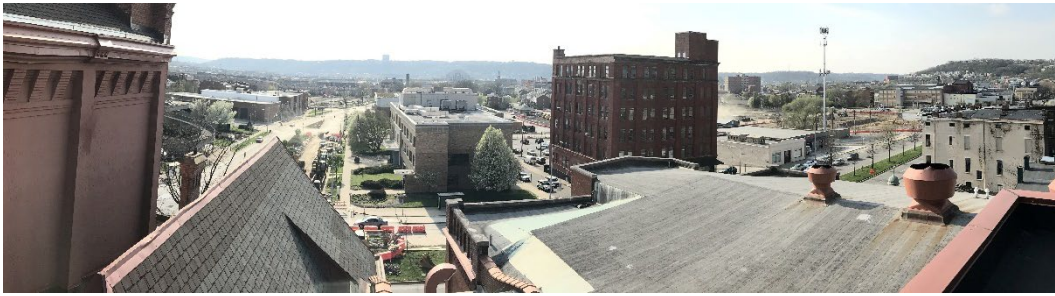
Figure A2 - View to the west and north from the rooftop microphone location

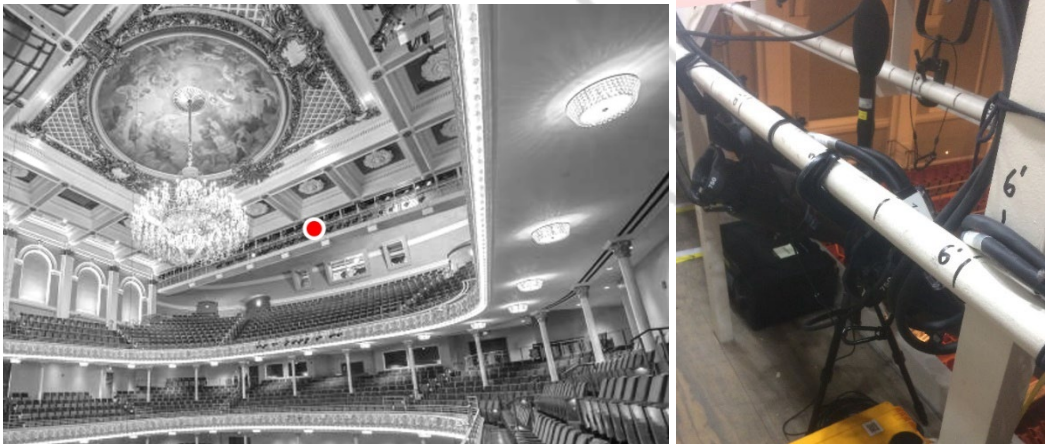
Figure A3 – Springer Auditorium interior logging kit location

Logging kit 3008358 was set up inside Springer Auditorium at the center of the theatrical lighting cove, as shown in

Figure A3. The microphone was located 3' above the floor of the lighting cove, 30' above the floor of the first row of the top balcony level and 44' below the pitched roof directly above. This location was chosen because it was the closest position to the audience inside the auditorium that would not obstruct day-to-day operations.

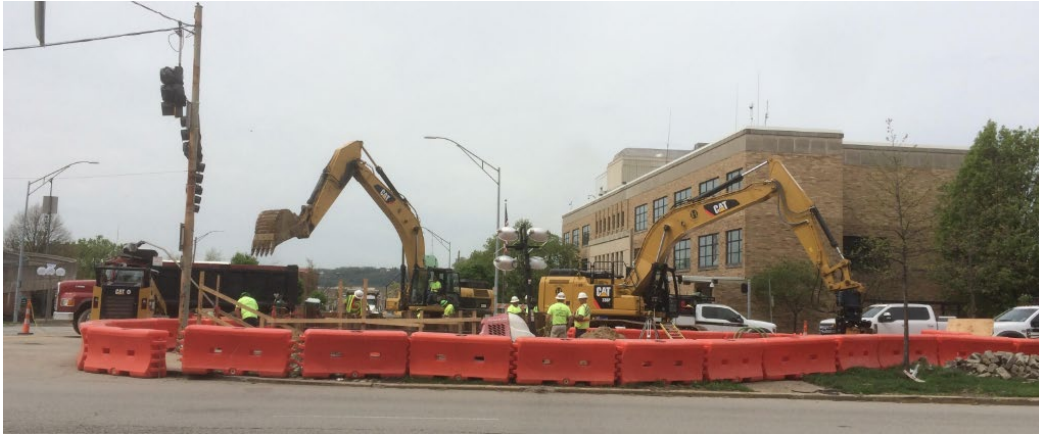
Figure A4 - Construction site at intersection of West Central Parkway and Ezzard Charles Drive

Over the course of the logging period there were several periods of ongoing construction noise from a road construction site at the intersection of West Central

Parkway and Ezzard Charles Drive, directly adjacent to CMH and visible from the rooftop microphone position. The construction site is shown in Figure A4.

Over the logging period were also intervals of high wind noise. During periods of both construction and wind noise, noises from other sources were audible in alert recordings but are excluded from our final data set due to the difficulty of determining which source triggered the alert during the one-minute measurement interval. Figure A5 summarizes periods of construction noise and wind noise that were identified by listening to the alert audio samples.

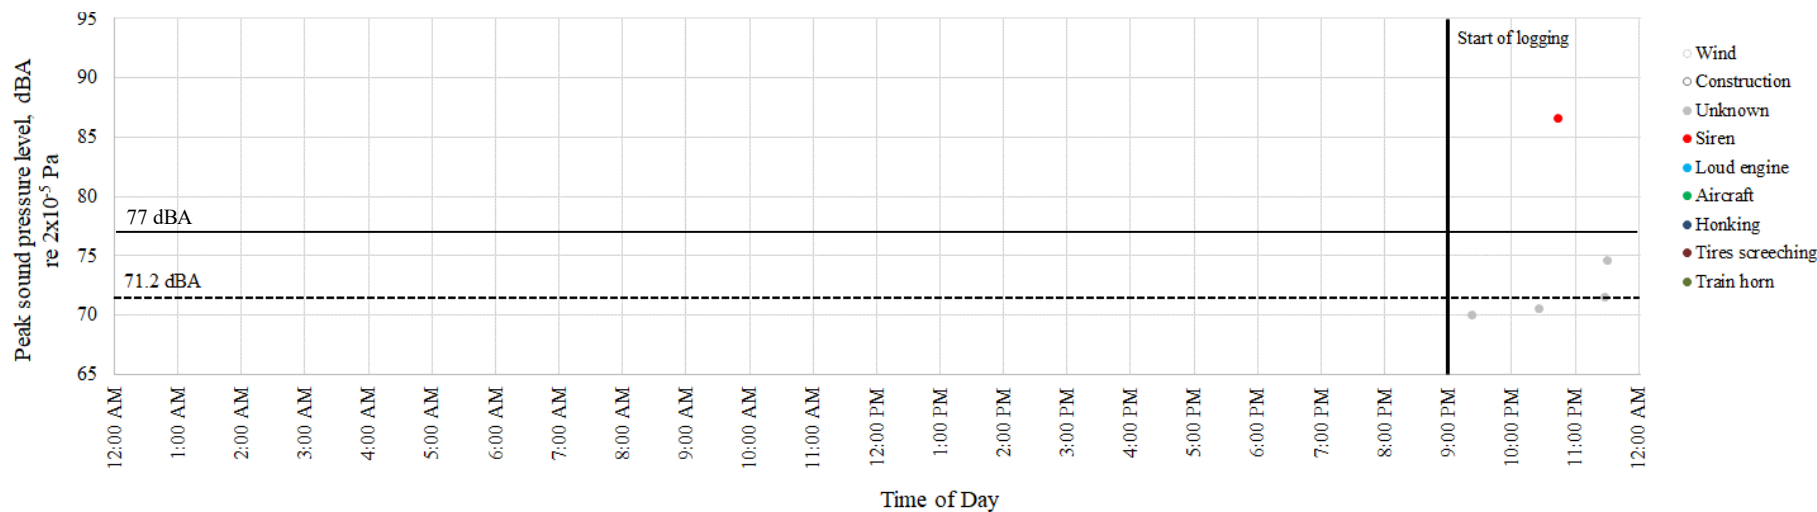
Figure B1 – Transient Noise Log for Wednesday, April 10, 2019

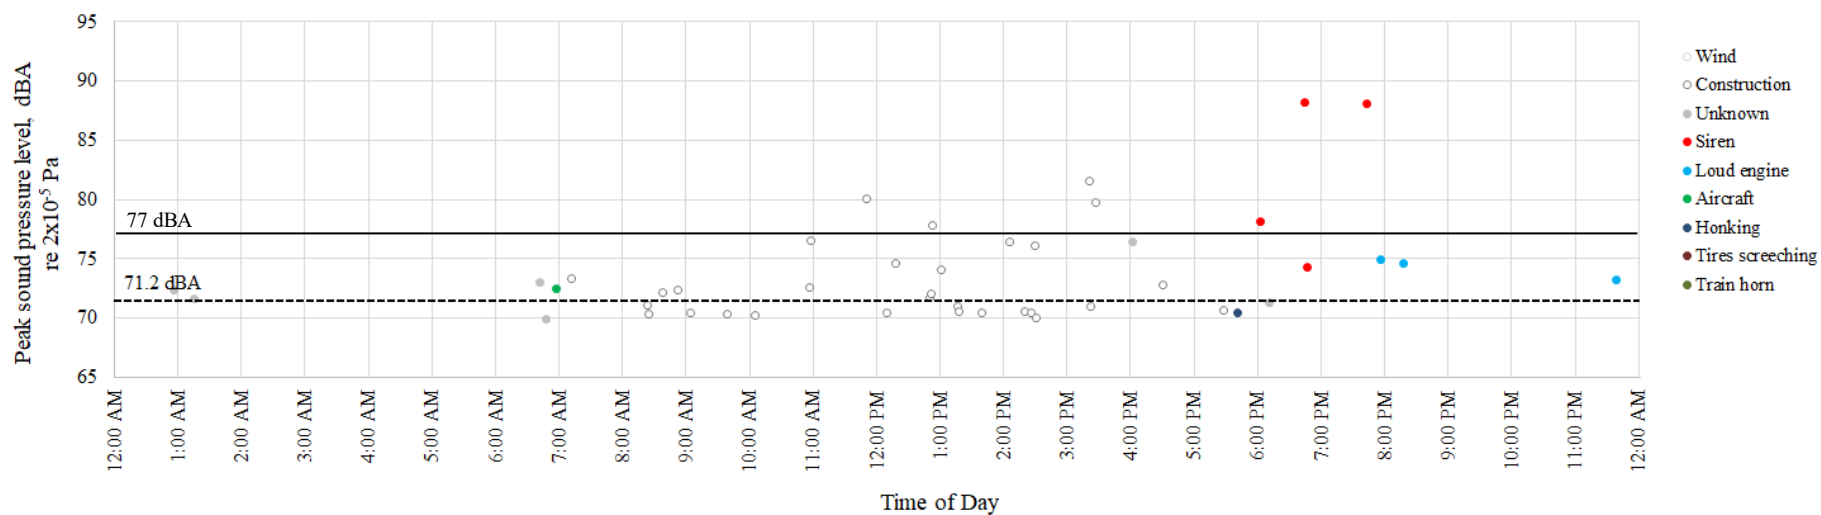
Figure B2 – Transient Noise Log for Thursday, April 11, 2019

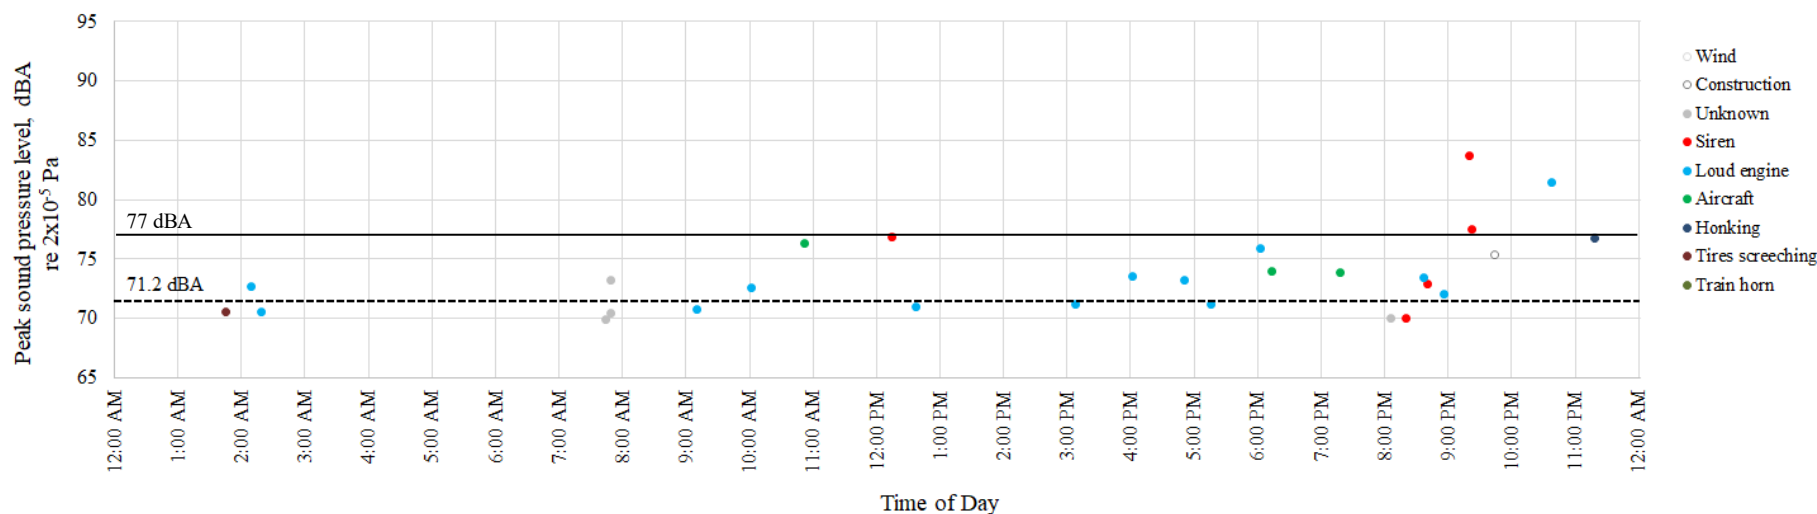
Figure B4 – Transient Noise Log for Saturday, April 13, 2019

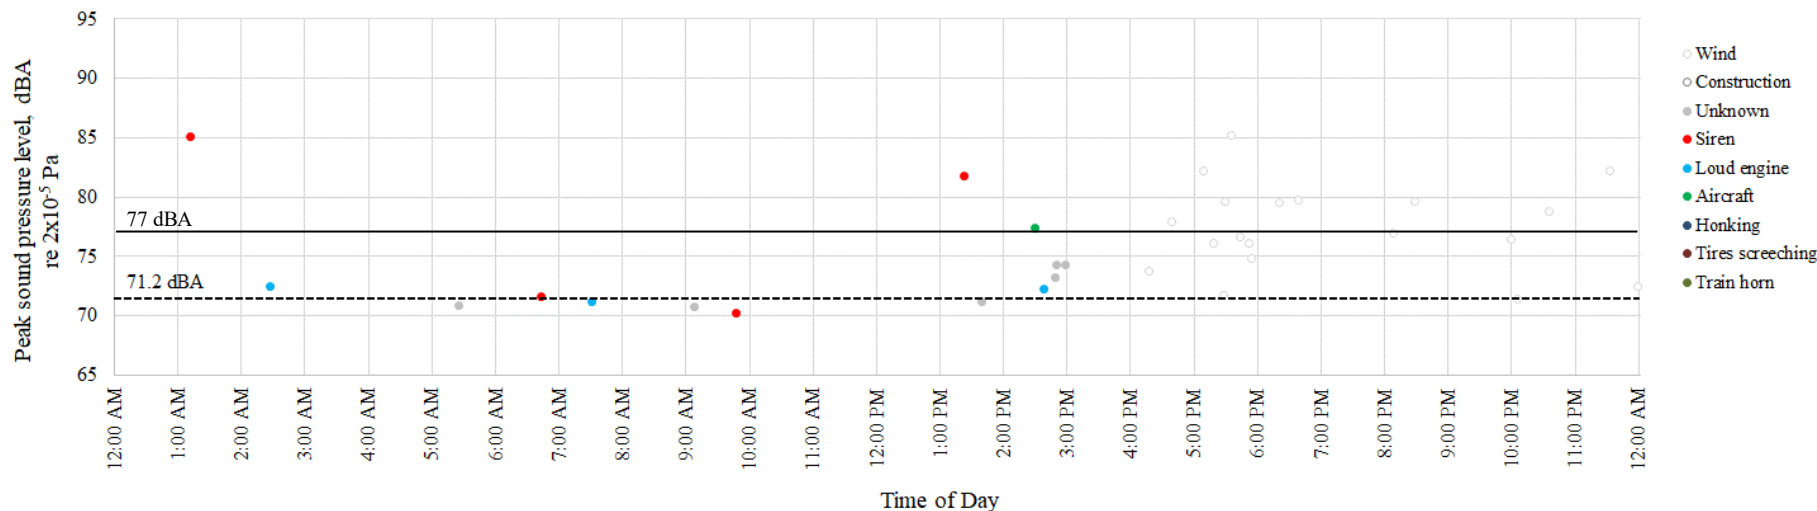
Figure B5 – Transient Noise Log for Sunday, April 14, 2019

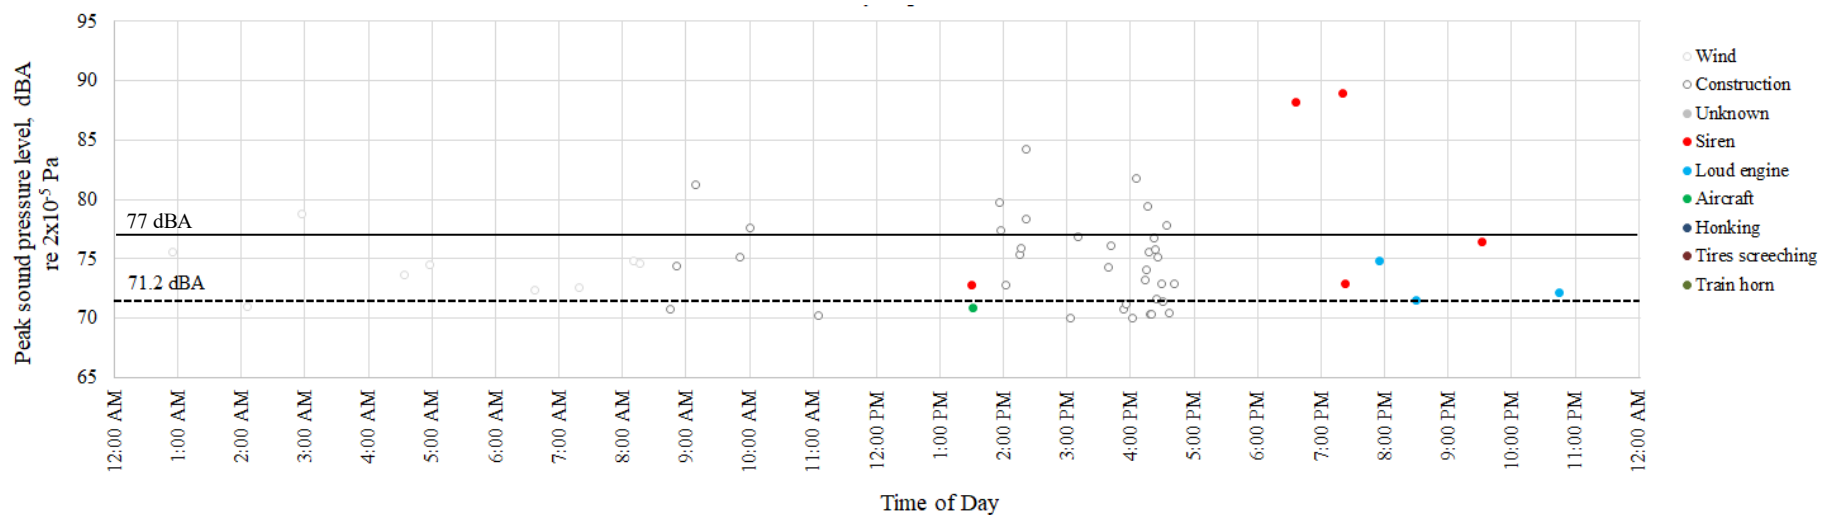
Figure B6 – Transient Noise Log for Monday, April 15, 2019

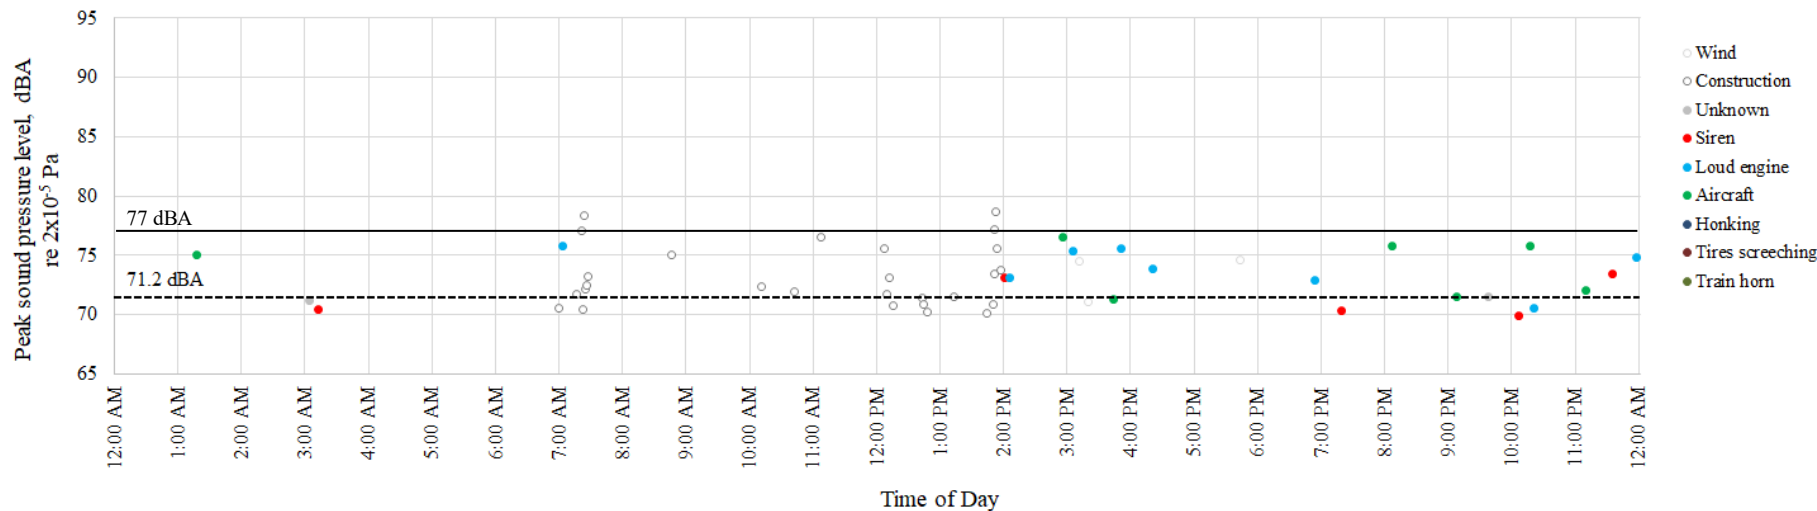
Figure B7 – Transient Noise Log for Tuesday, April 16, 2019

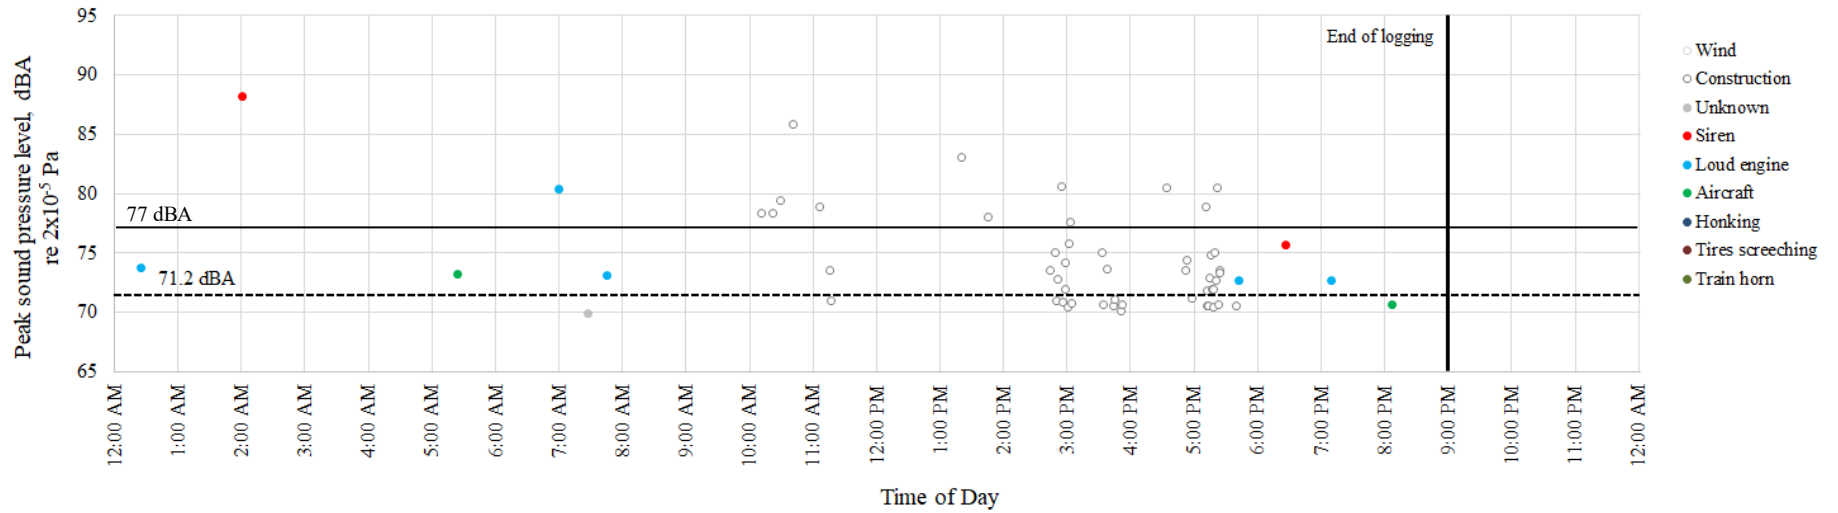
Figure B8 – Transient Noise Log for Wednesday, April 17, 2019

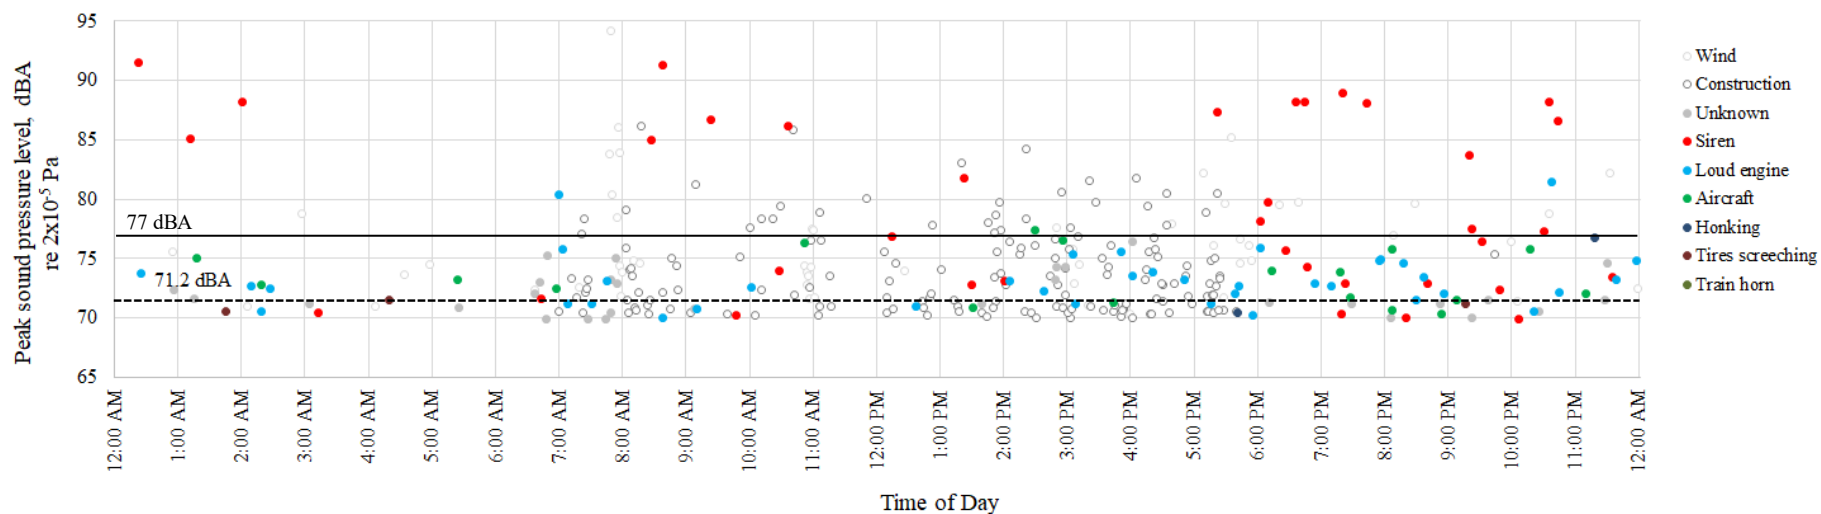
Figure B9 – Combined transient noise log for April 10 – April 17, 2019
